# Solar Reflector Materials Degradation Due to the Sand Deposited on the Backside Protective Paints

**Abstract:** Concentrating solar power (CSP) technologies are foreseen to be a crucial actor in the future renewable energy mix. Soil accumulation on the optical surfaces of CSP plants involves significant expenses of the operation and maintenance activities because a high cleanliness level is required to achieve proper plant revenues. Normally, only the front side of the solar reflectors is cleaned to reflect the maximum possible amount of direct solar radiation towards the receiver. However, soil deposited on the backside of the reflector could provoke degradation and might need to be considered in the cleaning strategy. As this possible degradation has never been studied, this work is dedicated to assess if the backside of reflectors should be regularly cleaned. The influence of the sand in the possible paint degradation depends on its chemical composition and the weather conditions. Therefore, several climatic conditions of artificially soiled reflector samples with different types of sand were simulated in accelerated aging tests. Concerning the results obtained, the ambient c

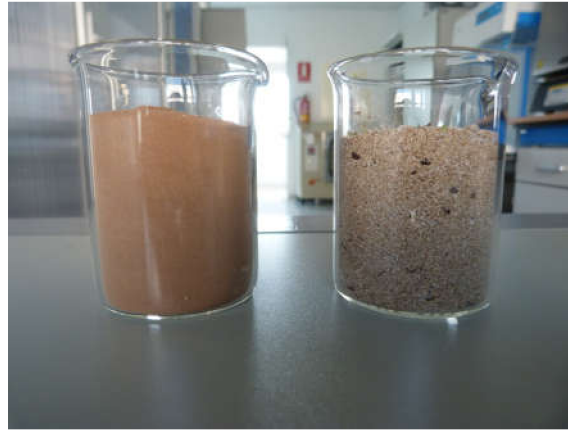
The two sand types are shown in Figure 2. As can be observed, the color of the sand from Morocco is red and the color of the sand from Dubai is light brown. The sand was sifted with a sieve shift, imposing a maximum of 180  $\mu\text{m}$  to simulate the particle sizes that might be expected to be deposited on the backside of the reflectors.

**Figure 2.** Picture of the two sands employed in the study, from Morocco (left) and the United Arab Emirates (UEA) (right).

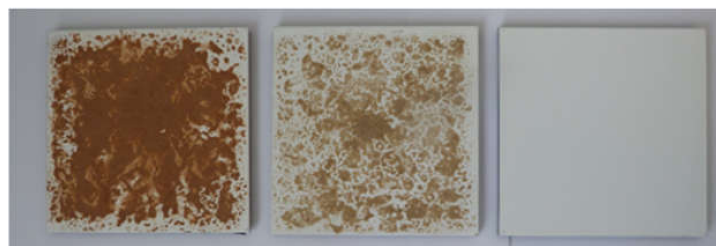
To deposit the sand on the backside of the reflector samples, the first step consisted in spraying demineralized water to wet the surface. After that, a weight of 1 g of sand was deposited with the fingers over the entire surface. Finally, demineralized water was sprayed again on the backside surface and the sand was kept dry for 24 h. The result after the 24 h is presented in Figure 5.

**Figure 5.** Picture of the set of samples after the sand deposition, with sand from Ouarzazate (left), with sand from Dubai (center), and without sand (right).
